Structural Appraisal

1 Property Road

Ref: 6917

Date: June 2016

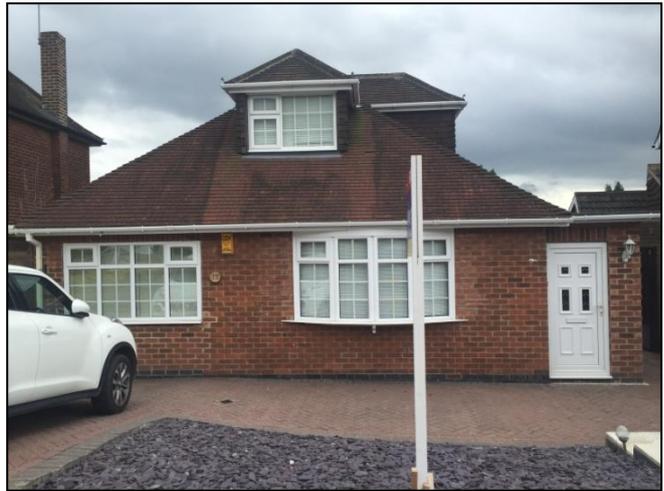
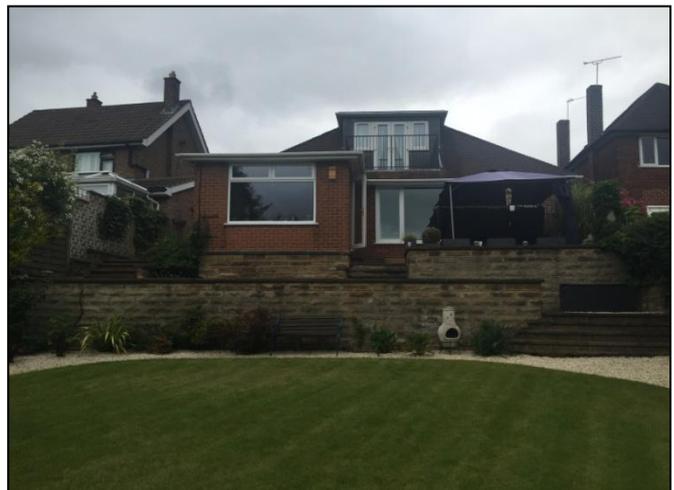
209. Approximately 2.6m from the kitchen extension is a 12m long retaining wall with a retained height of 1.2m.

210. The rear wall of the kitchen extension appeared to have been built off an existing retaining wall at approximately 1.2m in height.

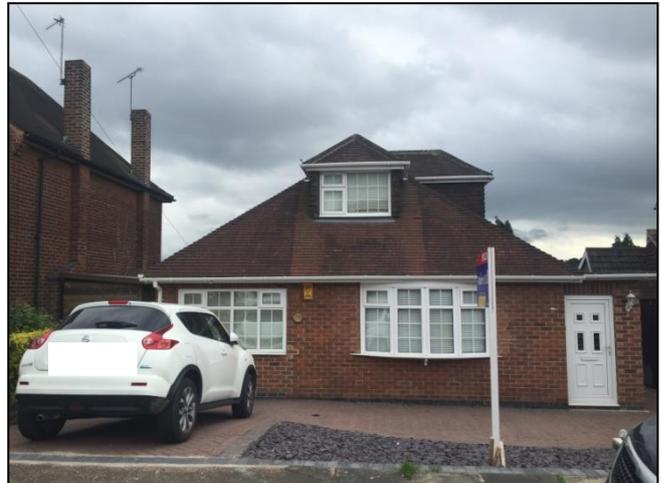
301. The masonry to the front elevation appeared to be in generally good condition with no evidence of any significant structural movement or cracking.
302. On the left hand section of the property there appears to have been the original garage which has now been converted into a bedroom. The bottom section of the door has been bricked up and a window inserted above.

303. The brick flat arch lintels appeared to be in generally good condition with no evidence of any significant deflection.
304. There was no evidence of any significant settlement of the paved patio area adjacent to the front of the property.

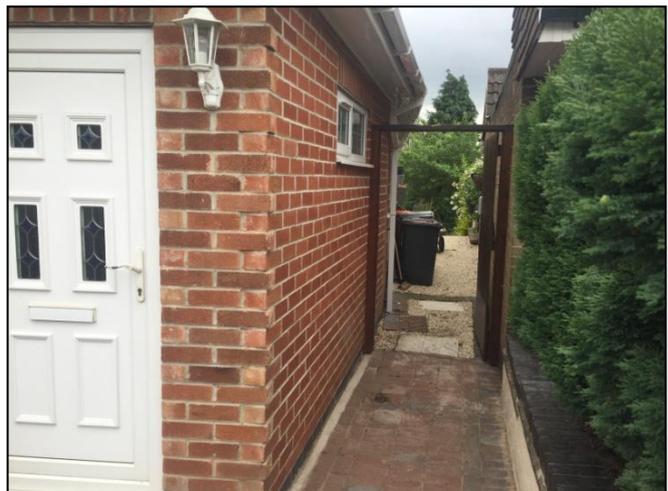
306. The masonry to the right hand elevation appeared to be in generally good condition with no evidence of any significant structural movement or cracking, however where the rear kitchen extension abuts the original property there is a vertical crack approximately 2-3mm in width at roof level dropping down vertically to hairline in width approximately 300mm above ground level. It is likely that the cracking was due to slight historic initial movement soon after the construction of the extension, and is not considered structurally significant.

307. A spirit level laid along the masonry of the extension appeared to show the wall was dipping down very slightly toward the rear.

503. The cracking noted on the right hand elevation where the kitchen abuts the original property is not considered to be structurally significant and can be cosmetically repaired, however the cracking may reopen to hairline but this is not considered structurally significant.

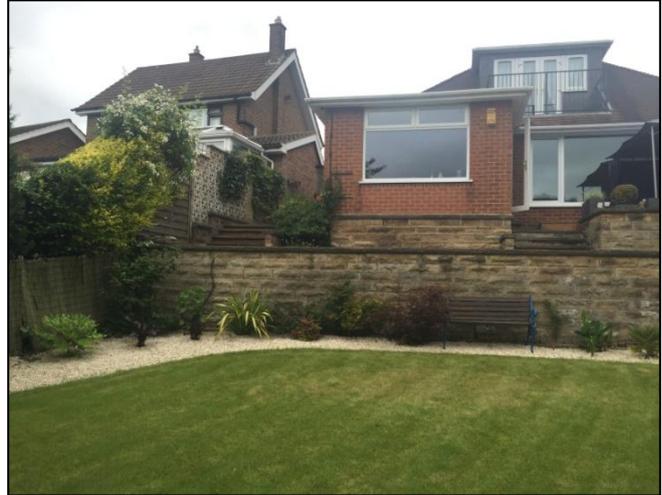
308. The masonry to the rear elevation of the main body of the property appeared to be in generally good condition with no evidence of any significant structural movement or cracking.

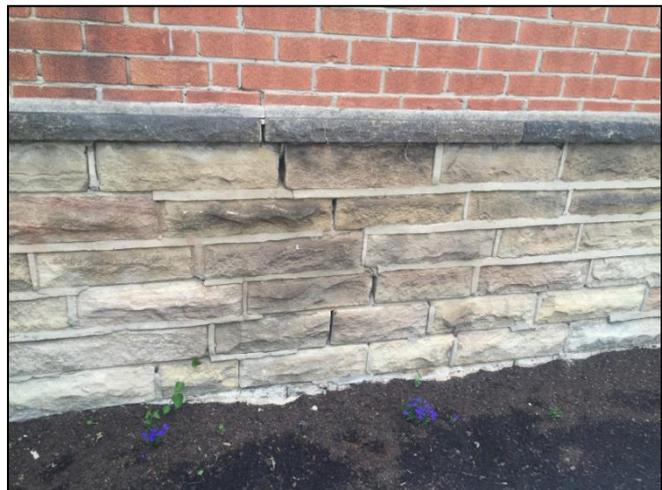
309. The rear kitchen wall appears to have been built off the original dressed stone retaining wall. This appeared to be in generally good condition, however there is a crack approximately 2mm in width dropping down towards the left hand elevation. This crack is not thought to be structurally significant and is made to look wider due to missing mortar in the joints.

310. A spirit level laid across the top of the retaining wall appeared to show it is generally level.

504. The cracking noted in the masonry under the rear kitchen window is not considered structurally significant and appeared larger due to missing mortar. We would recommend that this area is repointed.

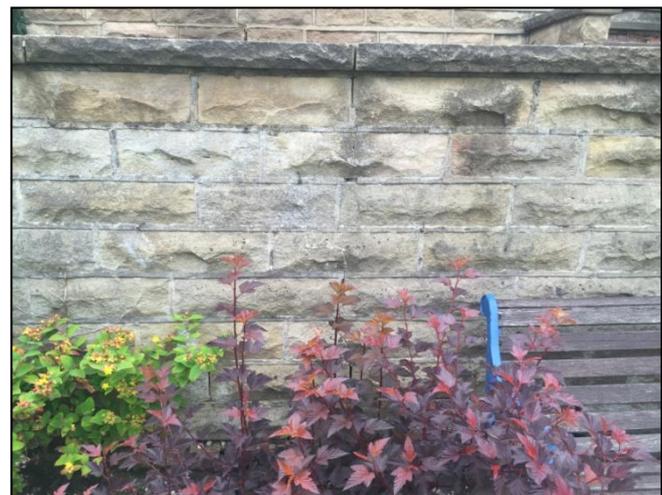
311. At the rear of the property approximately 2.6m from the rear kitchen wall is a retaining wall retaining a height of approximately 1.2m. The wall is constructed of dressed stone and appeared to be in generally good condition, however a spirit level laid vertically on the wall appeared to indicate that it is leaning out over its height by approximately 50-75mm.

505. The retaining wall at the rear of the property appeared to be in generally good condition, and although it is leaning out slightly this not considered to be structurally significant and is not untypical of walls of this age and construction. The vertical crack within the retaining wall is not considered structurally significant, particularly as it is south facing, but it is recommended that the soil level be raised to ensure that the wall foundation is not exposed.
