Structural Appraisal

1 Property Road

Ref: 6917

Date: June 2016

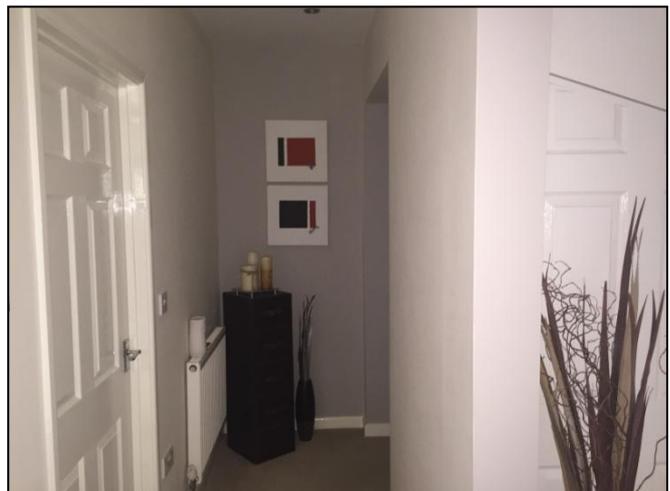
Original Entrance Hall

409. At the rear of right hand end of the passage there is an open entrance into the entrance hall.

410. The walls are plastered and painted and appeared to be in generally good condition with no evidence of any significant structural movement or cracking.

411. Due to the presence of a timber floor covering a detailed inspection of the suspended floor could not be made, however it appeared to be in generally good condition with no evidence of any significant deflection.

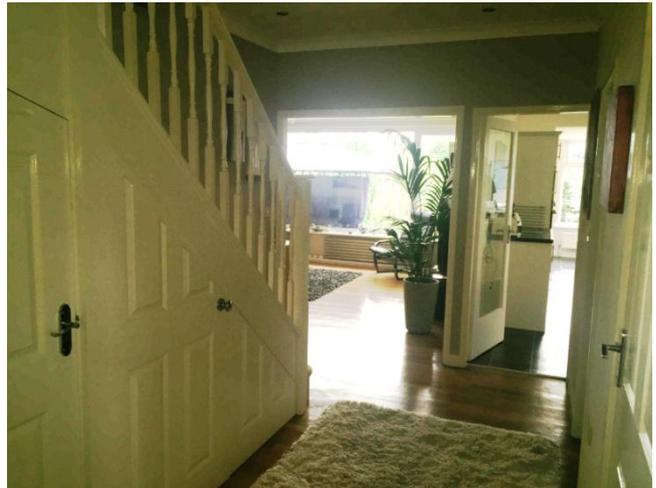
412. Spanning from the right to the left hand wall on the front wall is a beam which appeared to be in generally good condition with no evidence of any significant deflection.

413. The ceiling is plastered and painted and appeared to be in generally good condition with no evidence of any significant deflection.

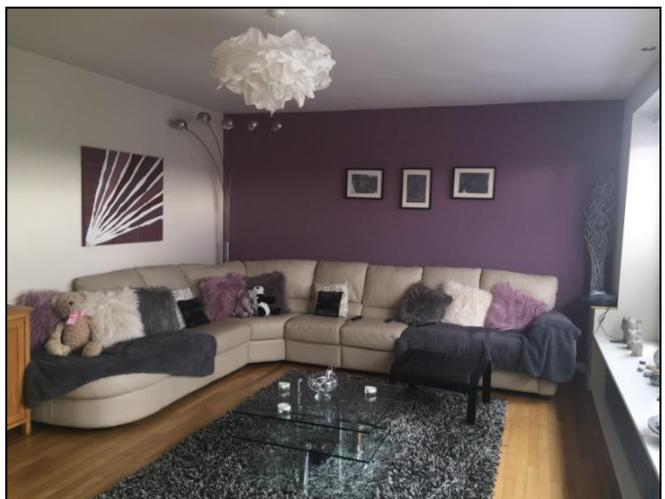
417. The ceiling is plastered and painted and appeared to be in generally good condition with no evidence of any significant structural movement or cracking.

418. The lintel above the rear wall window appeared to be in generally good condition with no evidence of any significant structural movement or cracking. We understand from the homeowner that the original was replaced by a steel lintel approximately 10 years ago.

-
419. Spanning from the right to left is a beam over the entrance opening which appeared to be in generally good condition with no evidence of any significant structural movement or cracking.

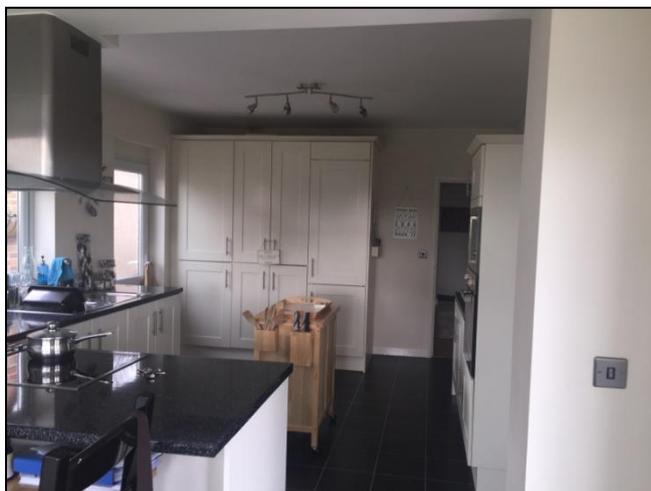
422. Due to the presence of vinyl flooring a detailed inspection of the timber suspended floor could not be made, however it appeared to be generally level with no evidence of any significant deflection.

423. Spanning from the left to right hand walls carrying the original rear wall and roof of the property is a beam which appeared to be in generally good condition with no evidence of any significant structural movement or cracking.

424. The ceiling is plastered and painted and appeared to be in generally good condition with no evidence of any significant structural movement or cracking.

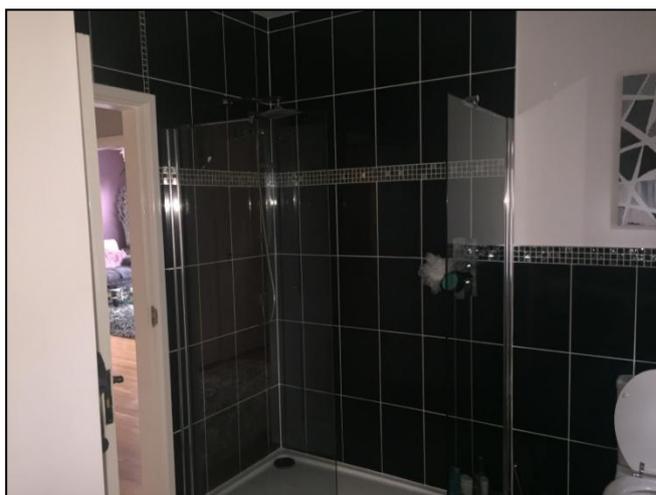
428. The ceiling is plastered and painted and appeared to be in generally good condition with no evidence of any significant deflection.

-
429. Spanning from the right to the left hand wall approximately halfway across the bathroom is a boxed out beam which appeared to be in generally good condition with no evidence of any significant deflection.

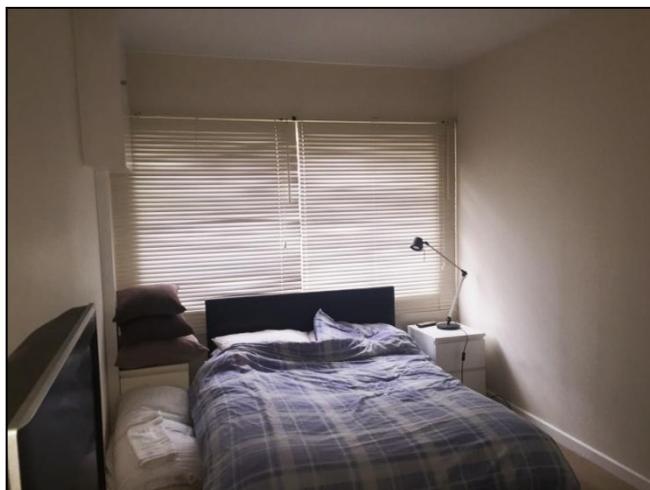
433. The ceiling is plastered and painted and appeared to be in generally good condition with no evidence of any significant deflection or cracking.

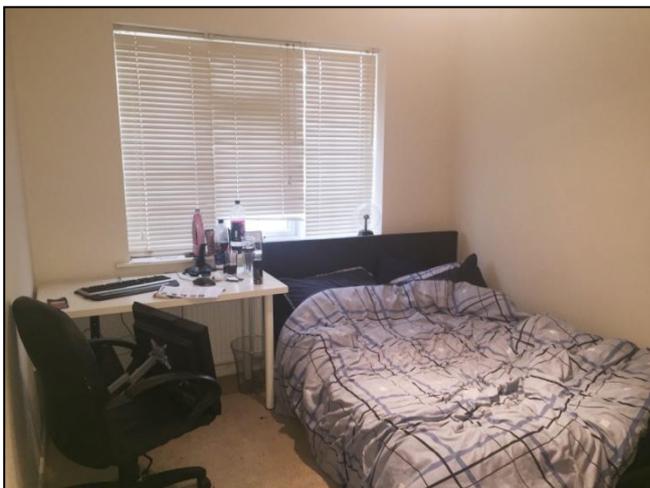
437. The ceiling is plastered and painted and appeared to be in generally good condition with no evidence of any significant deflection.

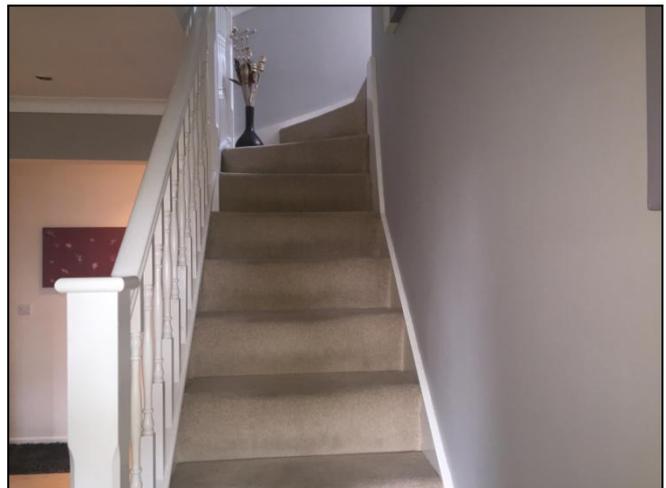
Landing

446. The walls are stud partition, plasterboard and painted and appeared to be in generally good condition with no evidence of any significant structural movement or cracking.
447. Due to the presence of carpet a detailed inspection of the timber floor could not be made, however it appeared to be in generally good condition with no evidence of any significant deflection.
448. The velux window in the roof appeared to be in generally good condition with no evidence of any water ingress or deterioration of the timber.
449. The ceiling is plasterboard and painted and appeared to be in generally good condition with no evidence of any significant structural movement or cracking.

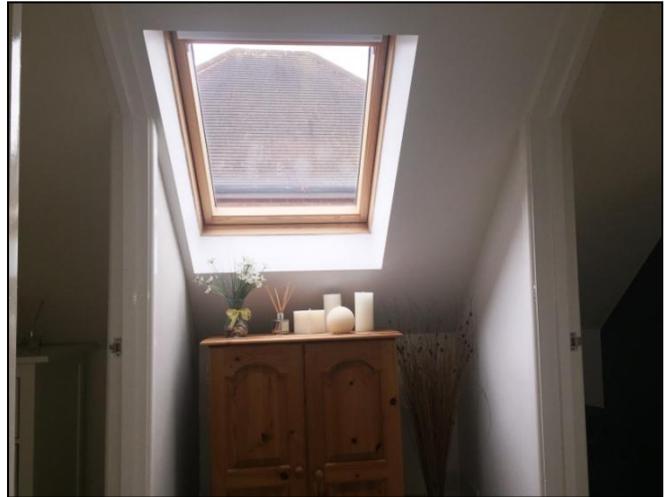
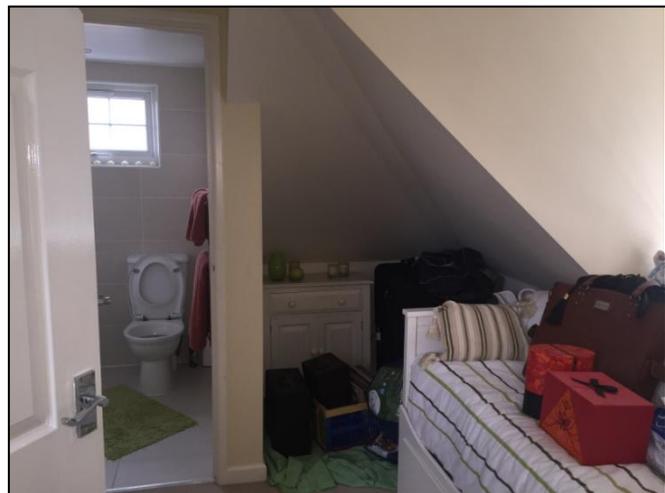
Bedroom Four

450. Bedroom four is located within the front section of the property.
451. The stud walls are plastered and painted and appeared to be in generally good condition with no evidence of any significant structural movement or cracking.
452. Due to the presence of carpets a detailed inspection of the timber floor could not be made, however it appeared to be in generally good condition with no evidence of any significant deflection.
453. The ceiling is plastered and painted and appeared to be in generally good condition with no evidence of any significant deflection.

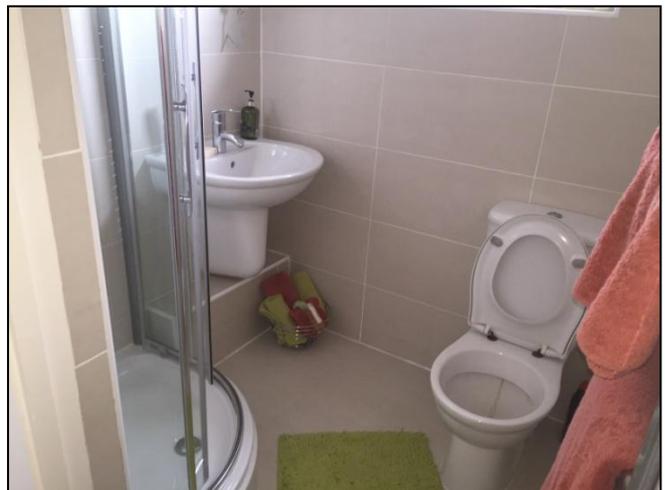
Bedroom Four En Suite/Shower Room

454. The walls are tiled to full height and appeared to be in generally good condition with no evidence of any significant structural movement or cracking.

-
455. Due to the presence of floor tiles a detailed inspection of the timber floor could not be made, however it appeared to be in generally good condition with no evidence of any significant deflection.
456. The ceiling is plastered and painted and appeared to be in generally good condition with no evidence of any significant structural movement or cracking.

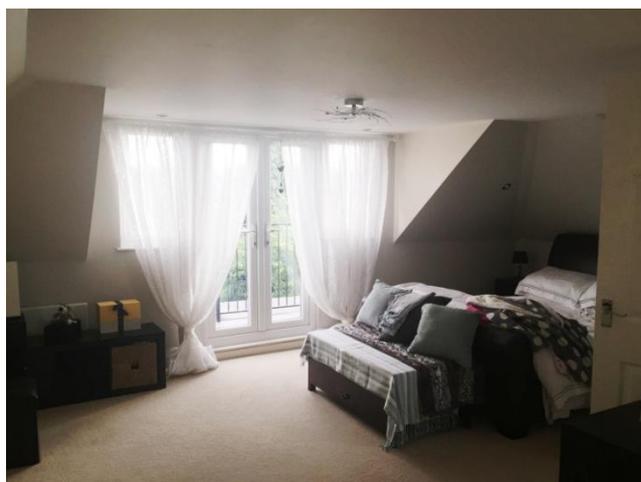
460. The ceiling is plastered and painted and appeared to be in generally good condition with no evidence of any significant structural movement or cracking.
461. On the rear wall of the bedroom are doors leading out to a small balcony area.
462. Due to the presence of tiled flooring a detailed inspection could not be made, however it appeared to be in generally good condition with no evidence of any significant structural movement or deflection.

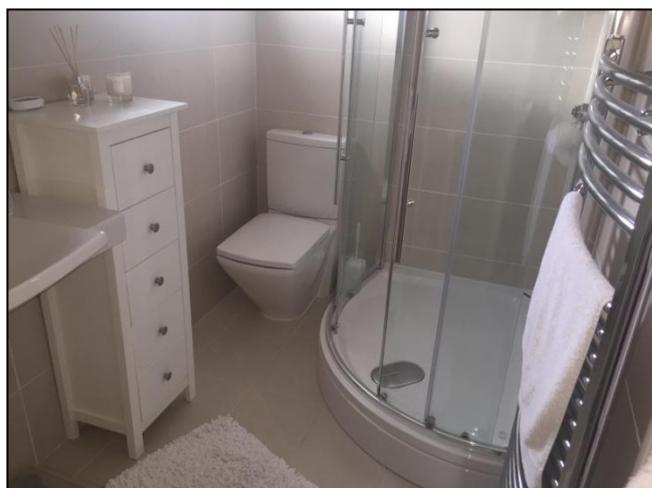
465. The ceiling is plastered and painted and appeared to be in generally good condition with no evidence of any significant deflection.
